INSTALLATION RESTORATION PROGRAM

PHASE I - RECORDS SEARCH

McGUIRE AFB, NEW JERSEY

NOVEMBER, 1982

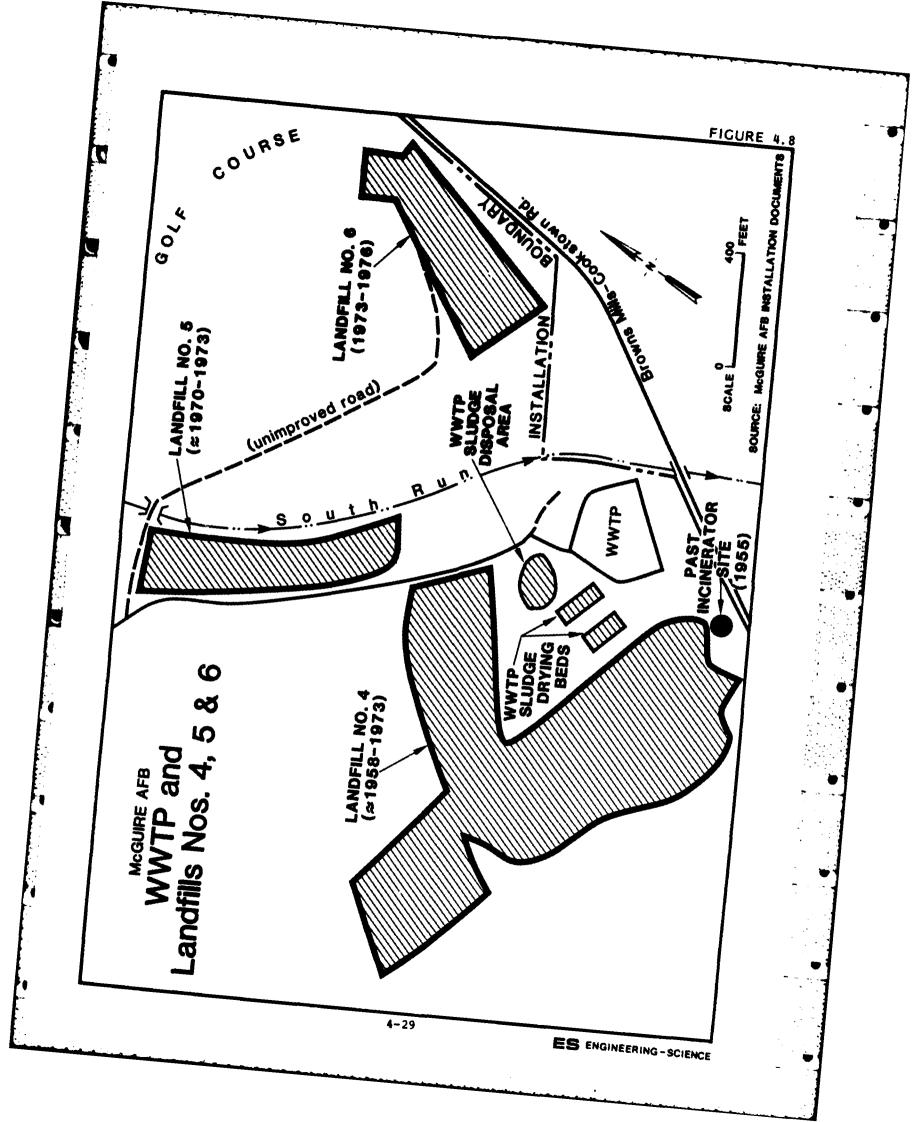
Landfill No. 4 is a long irregularly shaped 18 acre site located near the northeast end of the main runway (Figure 4.8). Disposal operations began in this area about 1958 and continued to the early 1970's. Fill operations began in the southernmost section of the landfill (now a portion of the EOD training area). Operations expanded to the west toward the main runway. By 1968, the section west of the wastewater treatment plant was actively used for landfilling. The landfill was operated primarily in a trench and fill manner. Trenches were approximately 15 feet deep and extended into the water table. No burning occurred in this la dfill. Wastes which were cited as being disposed of within this area included general refuse, coal ash and miscellaneous industrial chemicals, some in 55 gallon drums. A few empty 55 gallon drums were observed in a drainage swale which bisected a portion of the landfill. The site has been closed; however, furrows in the land are still evident indicating the location and orientation of the trenches (see photographs Appendix F). The site has been covered with a sandy soil supporting local grasses.

Landfill No. 5 was operated from about 1970 to 1973, simultaneous to the latter phase of Landfill No. 4 activity. The landfill comprised a long narrow parcel of land approximately three acres, located between a road leading up to the wastewater treatment plant and the bank of South Run Creek (Figure 4.8). This landfill was primarily used for the disposal of coal ash, wood and metal wastes; however, it was indicated by landfill personnel that waste chemical compounds may have been occasionally disposed of in this landfill. Waste materials were routinely burned to reduce volume. The site has been covered and presently supports grass, and shrub vegetation.
